NASA/TM-2016-218978

Ultrasonic Nondestructive Evaluation of Pultruded Rod Stitched Efficient Unitized Structure (PRSEUS) During Large-Scale Load Testing and Rod Push-Out Testing

*Patrick H. Johnston and Peter D. Juarez
Langley Research Center, Hampton, Virginia 23681*

May 2016

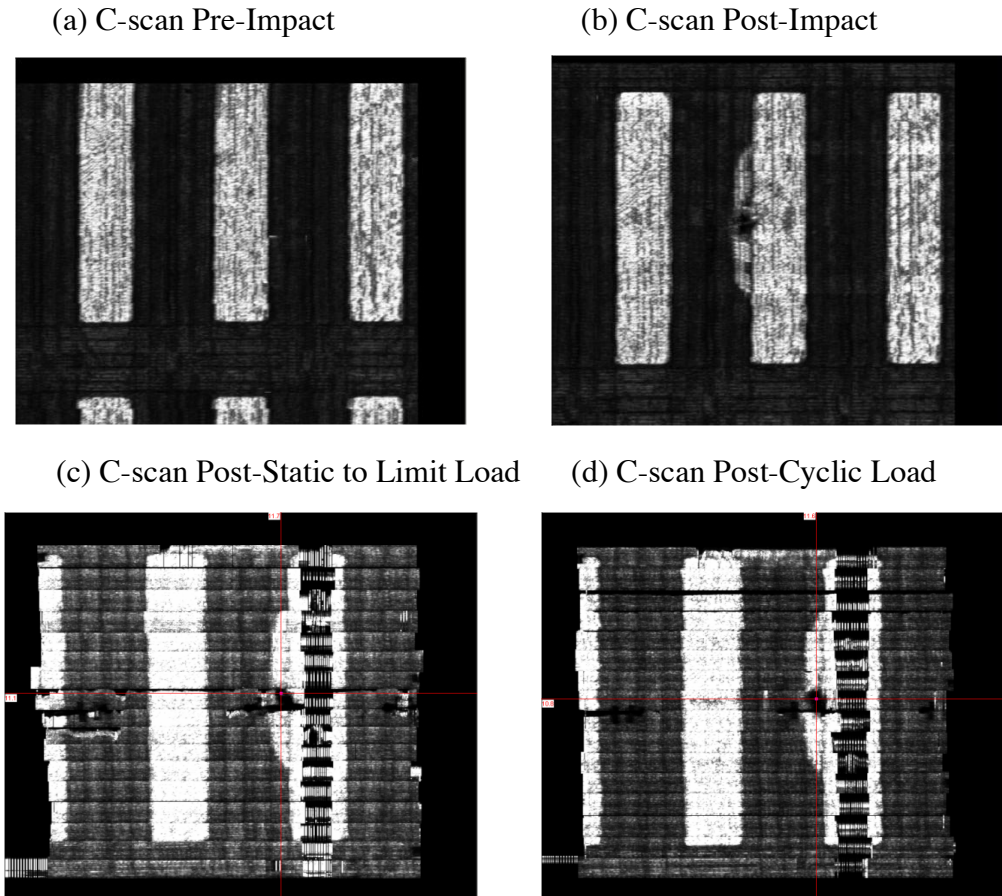
The results for this panel were previously reported at the 2010 Review of Progress in Quantitative Nondestructive Evaluation (QNDE) conference [12]. Figure 6 presents the PAUT pulse-echo C-scan results at various stages of the test. The grayscale represents the signal amplitude at the depth corresponding to the back surface of the free skin, so the back surface of the skin is gray, while the thicker flange regions are darker. Panels 6(a) and 6(b) show scans of the impact area before and after impact, respectively. A delamination is observed between the skin plies and the underlying flange plies, which runs vertically approximately 4" above and 4" below the impact point, while being held constrained in the horizontal direction by the first line of stitches encountered.

Figure 6(c) shows the C-scan obtained after the panel was loaded in static compression to its design limit load of 137,000 pounds. The dimensions of the delamination remained unchanged. Figure 6(d) presents the C-scan obtained after the panel was subjected to 20 cycles of compression up to 96,000 pounds. Again, the dimensions of the delamination at the BVID point remained unchanged.

FIGURE 6. C-scans (18"x20") of the flat 7-stringer panel (a) before and (b) after BVID, (c) after static loading to limit load, and (d) after 20 cycles of compression loading.

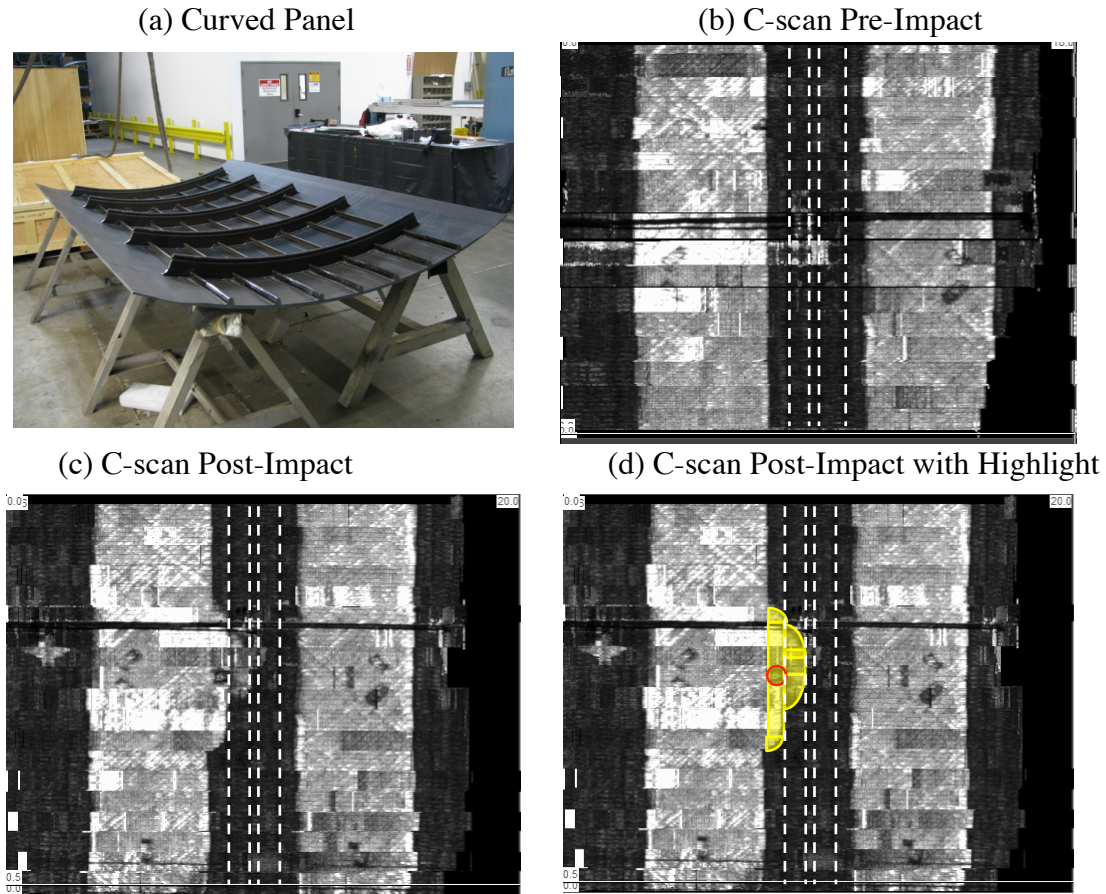
Ultrasonic C-scans of the BVID area before and after impact are presented in Fig. 7. There is a considerable amount of artifacts in these scans, caused by difficulty in performing a manual scan within the constraints of the load frame, but these could be distinguished from actual echoes by examining the A-scan waveforms. One such artifact is present in the center of Fig. 7(b). A-scan analysis showed that this area was free from delamination. The scan post-impact is presented in Fig.7(c), and also in Fig. 7(d) with the addition of a cartoon outline to highlight the delamination area. The formed delamination is similar to that observed in the flat compression panel, Fig. 6(c), with an additional small area of delamination between the first two stitch rows.

FIGURE 7. (a) Photograph of the curved test panel. (b) C-scan (18"x20") of panel before BVID. Rectangular indication at center is a signal artifact due to coupling. (c) C-scan of panel after BVID. (d) Post-impact C-scan with a cartoon outline to highlight the delamination and the impact point (circle).

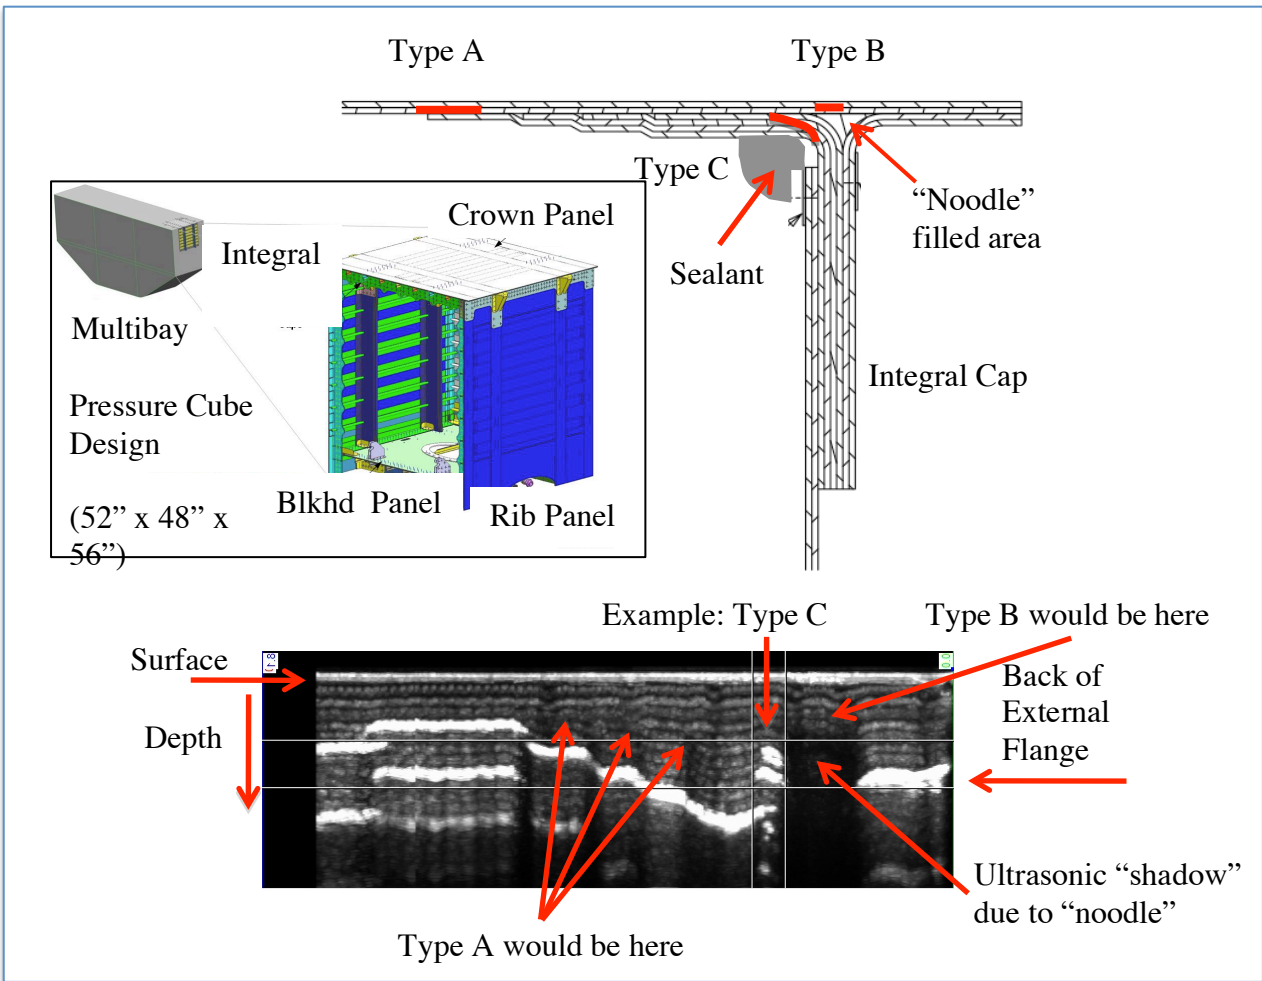
Scans of the remaining panels detected three distinct types of delaminations, distinguished by their locations in the structure. The drawing in Fig. 8 illustrates these three types, labeled A, B, and C. Type A delaminations occur between the laminae of the face sheet, tear or cap strap, and flange layers. The delaminations found in the flat 7-stringer panel and curved 7-stringer panel were of type A. The second delamination type B was observed in the skin or strap layer directly above a perpendicular web component, be it a stiffener, a frame, or an end cap. The final damage type C appeared in the inboard flange layers of end caps adjacent to the interior fillet. Figure 8 includes a B-scan data set of an integral cap to show an example of Type C damage and to illustrate the locations of Type A and Type B delaminations.

FIGURE 8. The PRSEUS pressure cube (inset) was designed to demonstrate the joint design intended for use on the full large-scale multibay test article. After loading the cube to failure, three types of delaminations were identified, based on location. Type A occurred between face sheet and flange plies; Type B delaminations occurred in the plies above the noodle of reinforcing structures. Type C delaminations occurred in the flange plies adjacent to the inner fillet of the integral cap webs. The fillet region was masked by an ultrasonic “shadow, believed to be caused by the noodle.

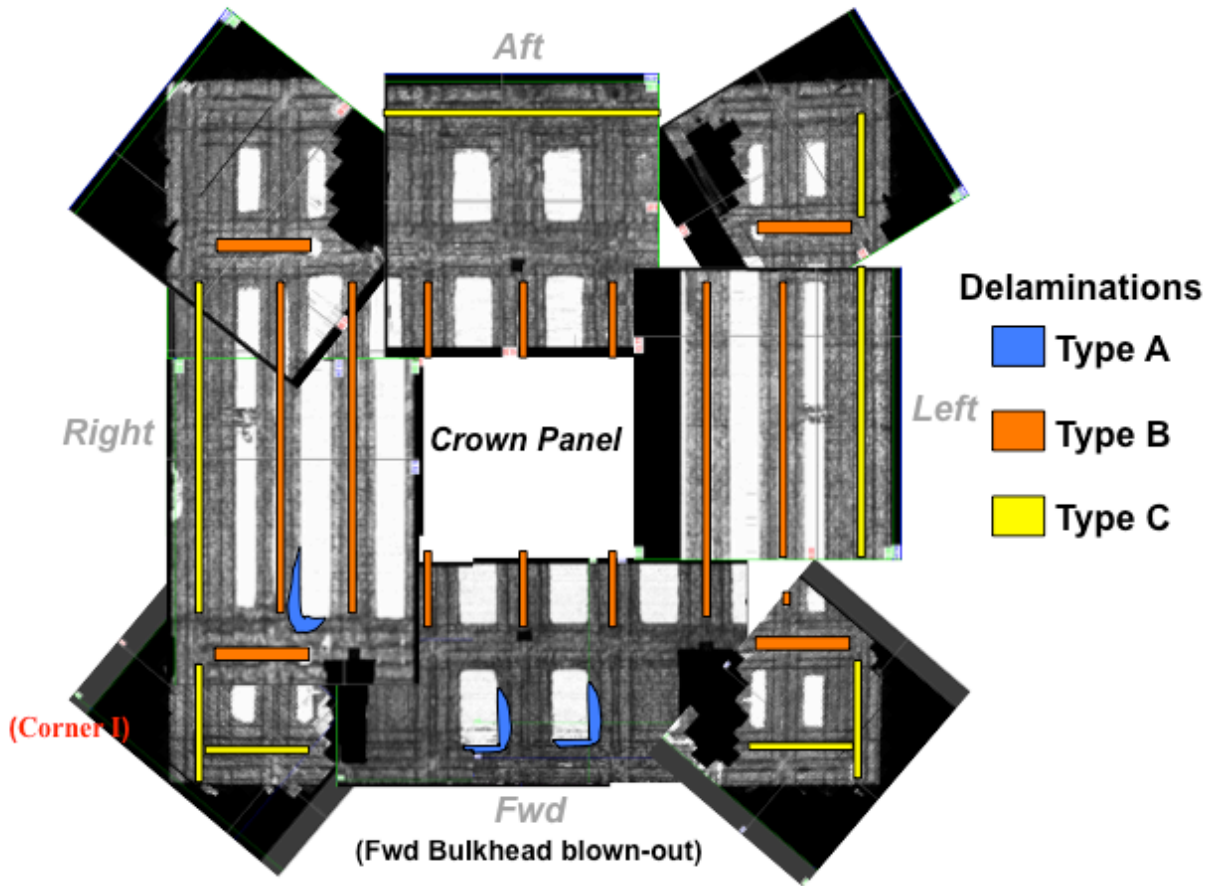
Crown Panel Delamination Summary

A summary of the results for the crown panel is given in Fig. 9. The results for the aft bulkhead and the right and left rib panels are similar in character. The metallic fitting which is believed to have initiated failure was located in the joint at the lower left corner of this figure. This will be referred to as corner I.

In the crown, three areas of Type A delamination were observed, near corner I and along the joint with the failed forward bulkhead. Similarly, on the right rib panel significant areas of Type A damage were along the joint with the forward bulkhead and near corner I. These delaminations were observed to cross stitch rows in places. Because of their location, the Type A delaminations are believed to have formed due to rapid, high intensity load redistribution during the time period between failure initiation in corner I and the final catastrophic failure of the forward bulkhead.

Type B delaminations are observed in Fig. 9 to occur in all of the stringers, extending the entire length between frames, and in the frame ends near each corner. The Type B damage is contained between the central two stitch rows in all of these areas.

FIGURE 9. A summary mosaic diagram of the delaminations observed in the crown panel of the PRSEUS Pressure Cube after failure. Each rectangular scan approximately 18"x20".

In the crown panel, Type C delaminations were observed along most of the length of the inner flange of the integral cap. Inboard, the observed Type C flaws did not extend beyond the second stitch row. However, because of the ultrasonic “shadow” above the cap webs (Fig. 8), the extent of these delaminations into the curved fillet was unknown.

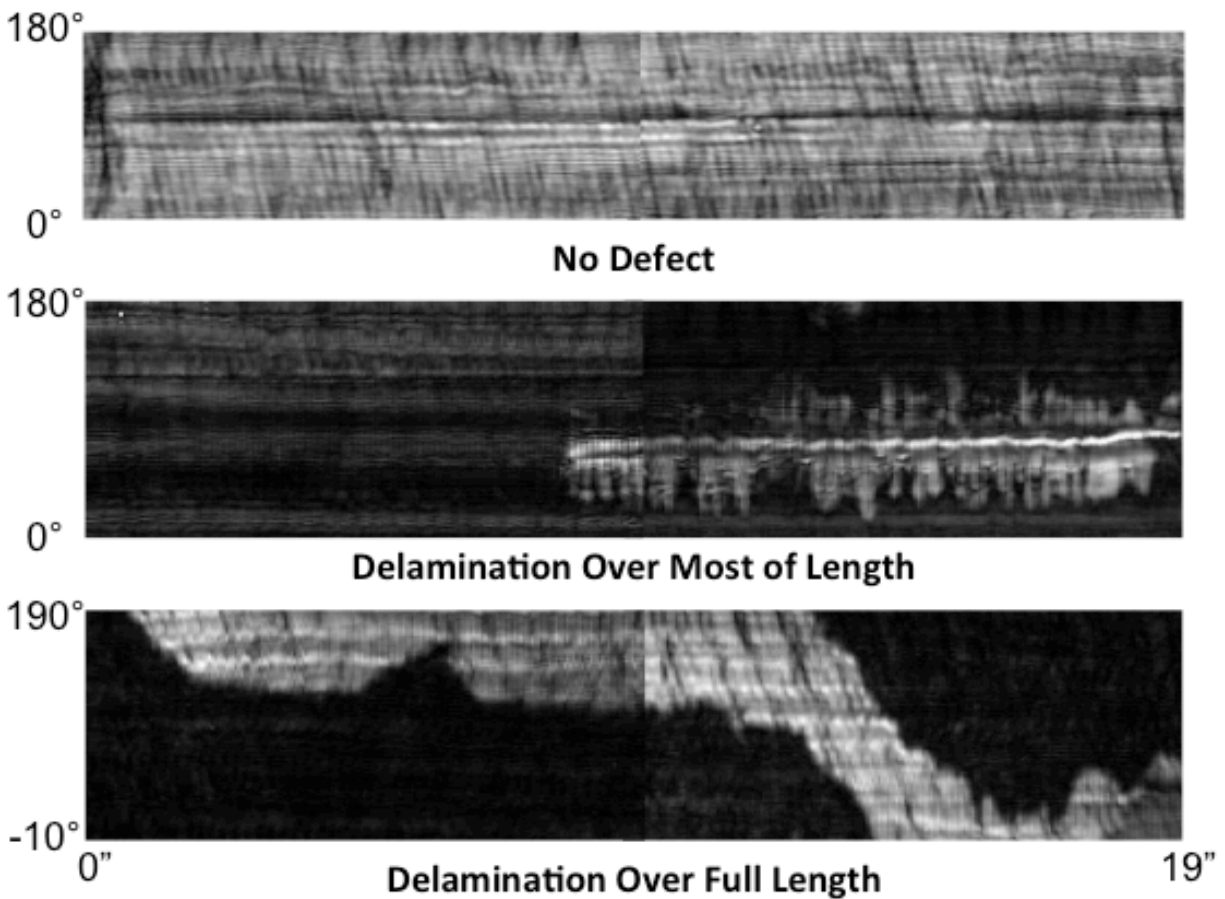
Immersion Scans of Three Rod-Wrap Interfaces

The middle and bottom images show two examples where existing delamination or extended voiding was observed. By means of these screening ultrasonic scans, specimens were selected for sectioning into short specimens for push-out testing.

FIGURE 12. Ultrasonic pulse-echo C-scans of three rod specimens prior to cutting into push-out specimens. In the upper scan, the ultrasonic response is relatively uniform, having only normal textural variations resulting from the fabric overwrap. In the center and lower scans, debonds between the overwrap and rod produce echoes much larger than the normal background.

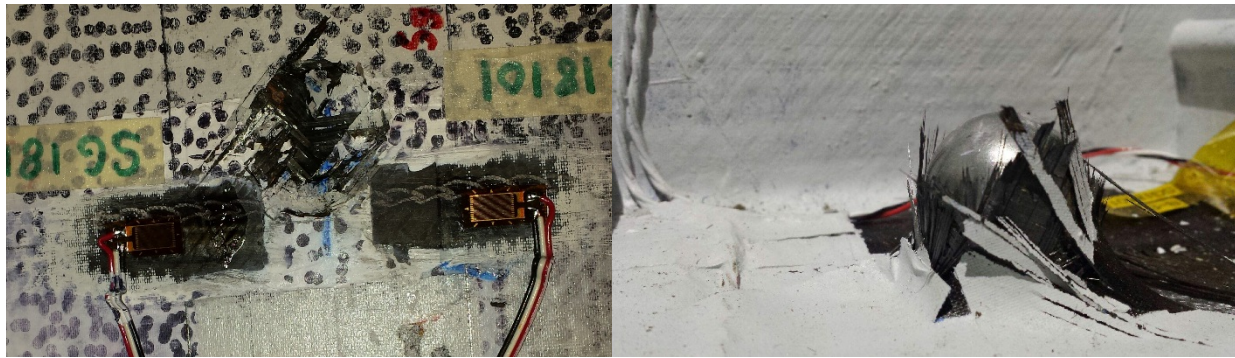
BVID site #1 on the keel panel of the MBB was located over the flange of the center frame. During the impacting of the frame flange, a positioning error was made in the impactor set-up. As a result, instead of the impactor hitting the frame, as intended, it hit open skin. Since the energy of this impact was set to produce damage in the thicker frame flange, the impactor penetrated the skin (Fig. 22). Because of its penetrating nature, this skin impact resulted in little delamination around the impact site. The delaminations that did occur extended toward the flange areas of the adjacent stringers, but were stopped by the first stitch row (Fig. 23).

FIGURE 22. Accidental penetrating impact on the keel.

The penetration was repaired in order to contain the pressure applied during subsequent testing. The repair was designed to simply contain the pressure, but not carry any skin loads.

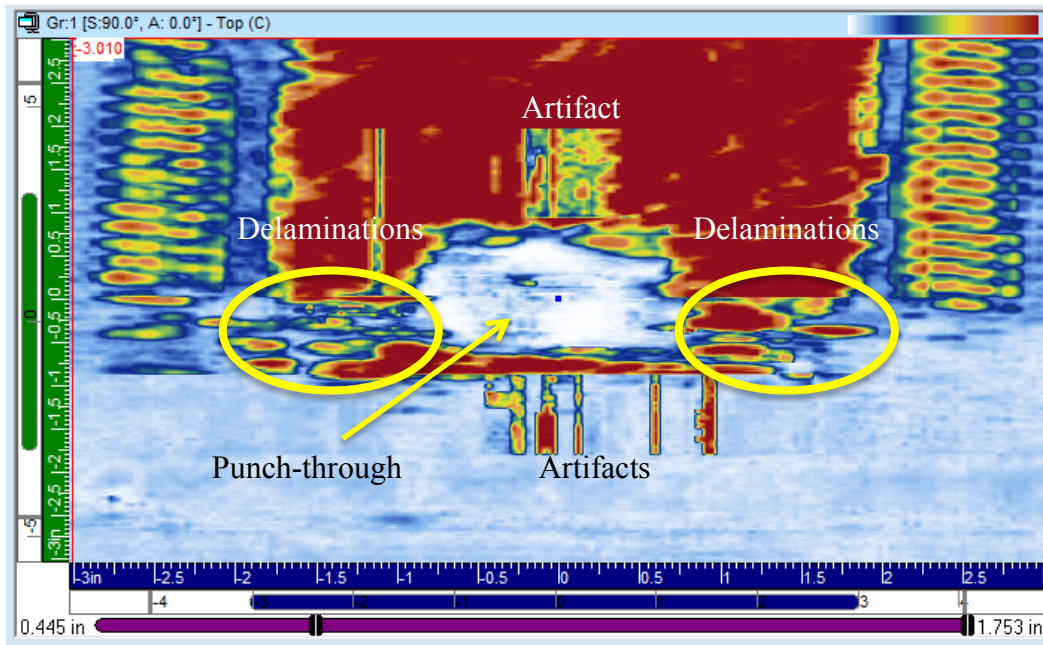
Scans performed at various times during the subsequent test sequence, including after catastrophic failure of the test article, indicated no growth in this damage area.

FIGURE 23. Ultrasonic data of the delamination damage caused by the center frame keel impact. Note that the artifacts in this image are a result of strain gage placement which cause an issue in coupling with scanning probe.

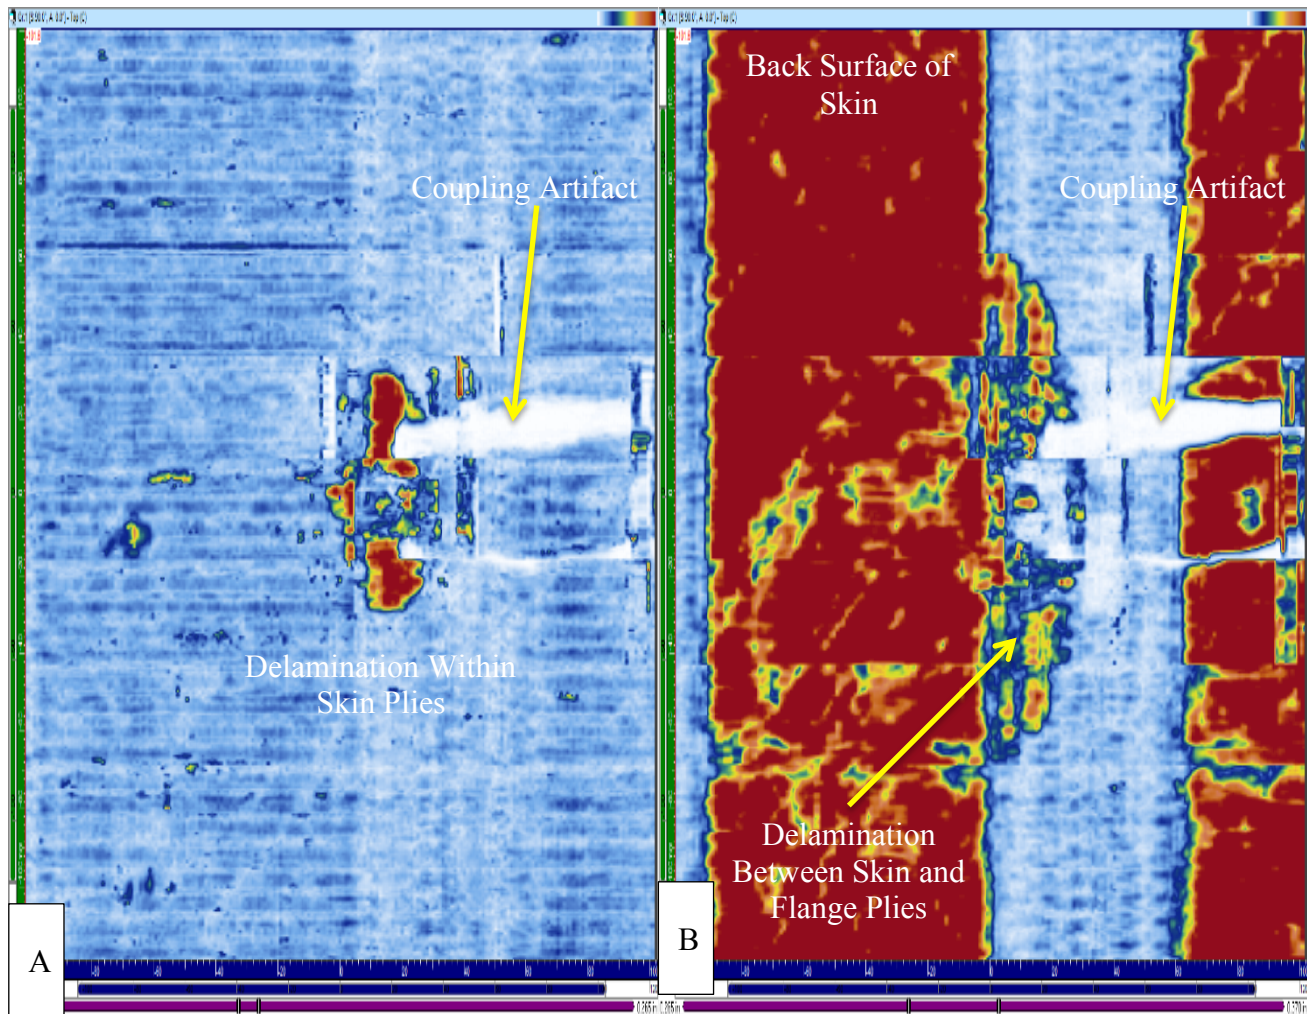
Keel BVID site #2 was located over the flange of a stringer. The impact caused delaminations within the skin layer (Fig. 24A), as well as a delamination at the interface between the skin layer and the stringer flange (Fig. 24B). The delamination within the skin was approximately 2.4 inches along the stringer by 1.1 inches across the stringer. The flange/skin interface delamination was approximately 5 inches along the stringer and 1.3 inches across the stringer. In addition to being contained laterally by the multiple stitch rows in the stringer, an examination of the delamination shows that the flange/skin interface damage along the length of the stringer also appears to stop at the location of an unbroken pair of stitches. Qualitatively, this result is similar to those observed in earlier panel tests (Figs. 6, 7).

Scans performed at various times during the subsequent test sequence, including after catastrophic failure of the test article, indicated no growth in this damage area.

FIGURE 24. Ultrasonic data of the keel impact on the stringer flange. A) delamination in the subsurface/skin layer, B) delamination in the stringer flange/skin layer interface.

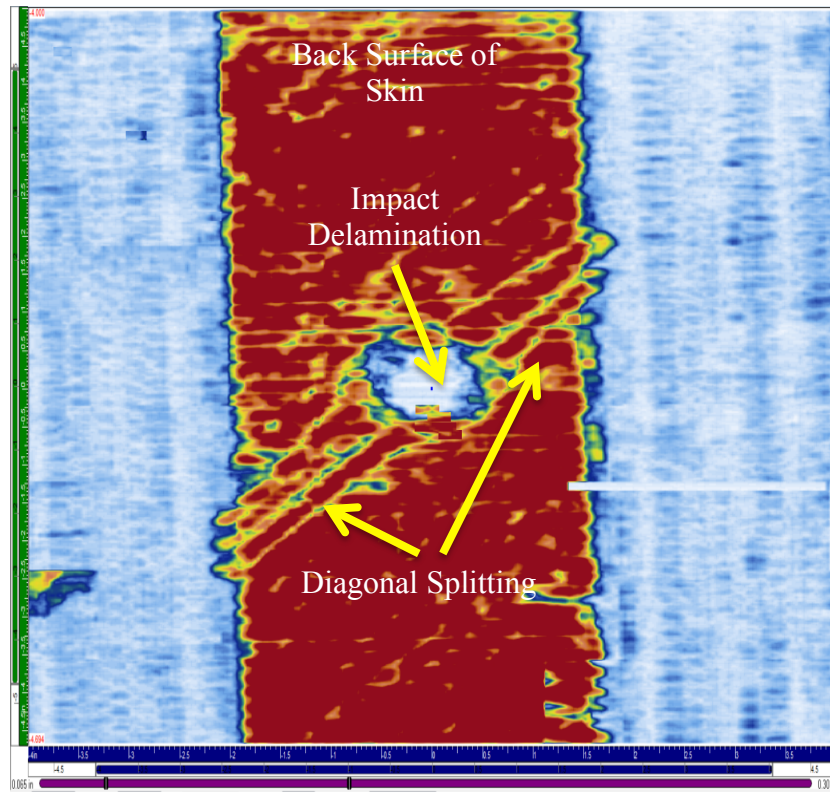
BVID site #3 on the keel was located on the unsupported skin at the center of a bay, midway between two stringers and two frames. On the inside surface of the skin this impact made delaminations and transverse cracking oriented along the positive 45 degree direction. This

damage stopped at the first stitch line of the stringer flanges on either end (Fig. 25). Beyond some smaller internal skin delaminations surrounding the impact site, this was main damage caused by the impact.

Scans performed at various times during the subsequent test sequence, including after catastrophic failure of the test article, indicated no growth in this damage area.

FIGURE 25. Ultrasonic data of the keel impact on the mid bay skin section.

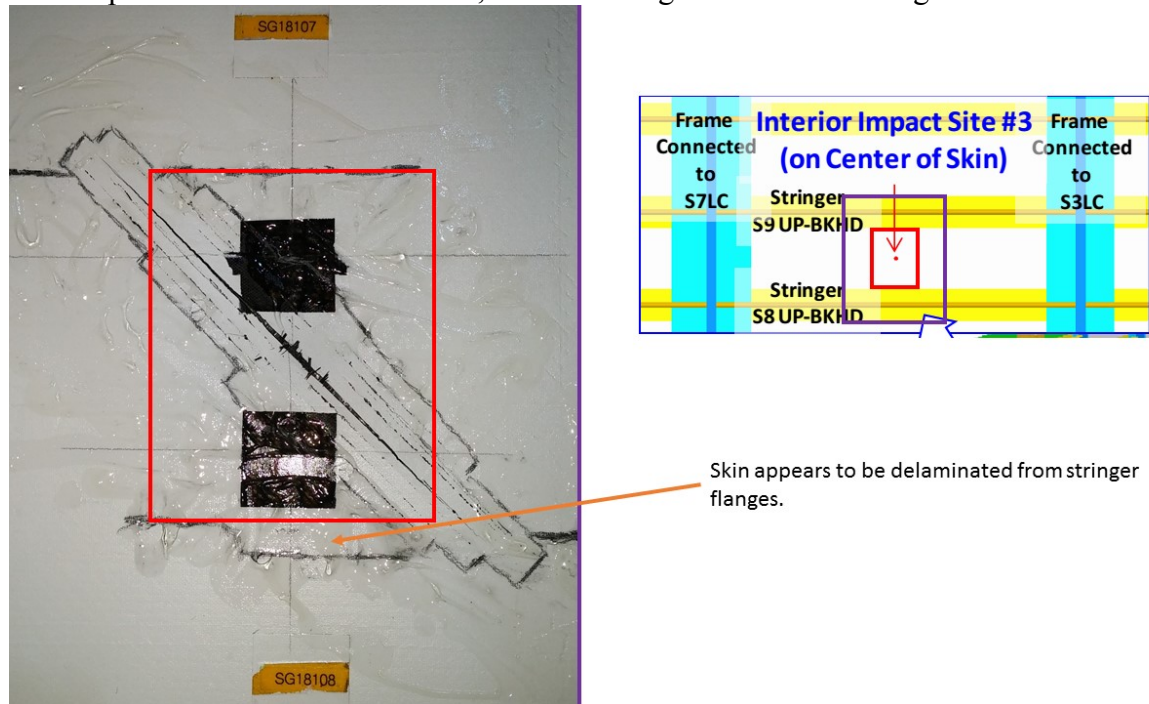
On the forward bulkhead, one interior impact site was also located on the unsupported skin at the center of a bay between two frames and two stringers (Fig. 26). Geometrical considerations dictated that the ultrasonic scans be performed from the outer skin surface. The cracked surface, with exposed broken fibers, did not permit the use of the phased array probes, so the site was scanned using a single-element ultrasonic probe and the area of delamination was marked on the surface of the MBB.

The damage was observed to be similar to that resulting from the skin impact on the keel (Fig. 25), with the diagonally-oriented delaminations and associated transverse cracking terminating at the first stringer flange stitch row encountered at each end.

Scans performed at various times during the subsequent test sequence, including after catastrophic failure of the test article, indicated no growth in this damage area.

FIGURE 26. Manual ultrasonic scan of forward bulkhead skin impact site. Impact was performed on inner surface of the skin, while ultrasonic inspection were performed from the outer surface of the skin. Delamination and transverse cracking was oriented along a diagonal fiber direction, extending to, and terminating at stringer flanges above and below the impact.

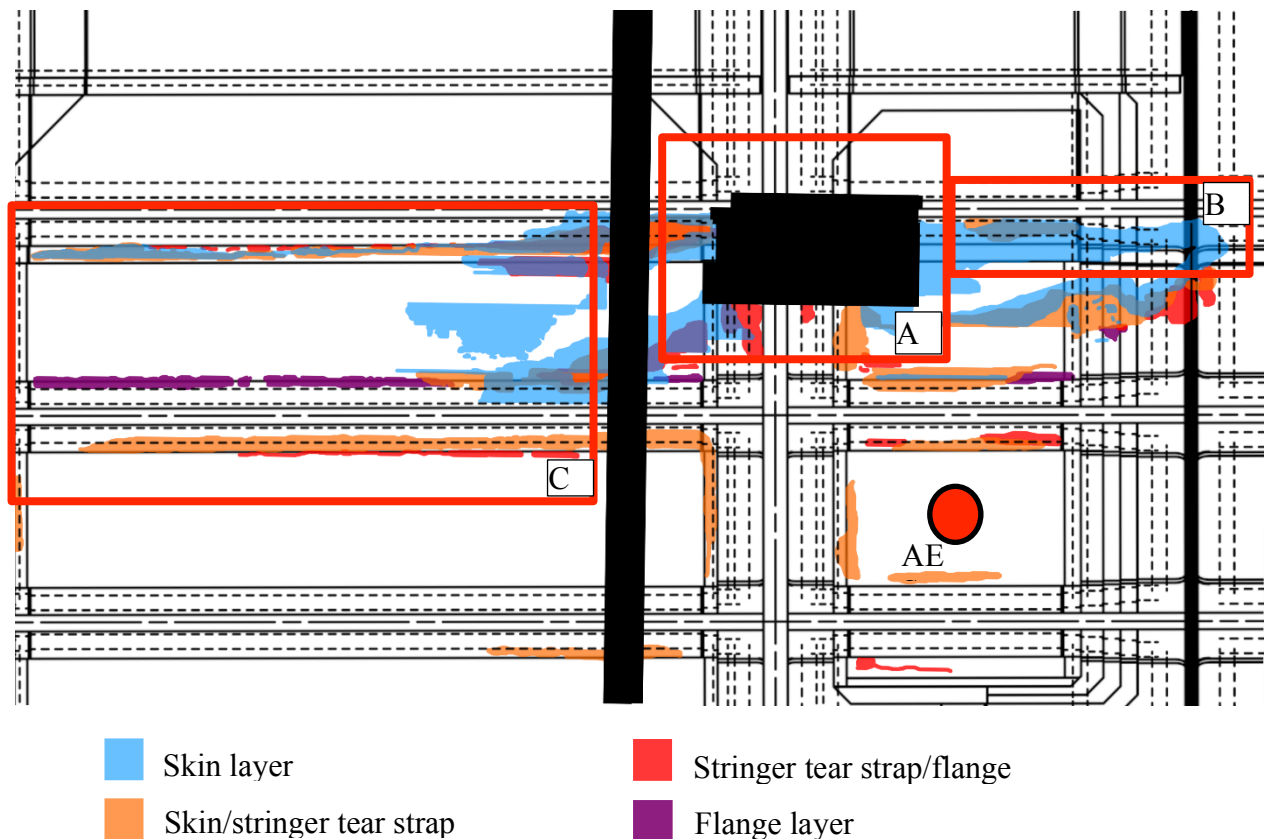
FIGURE 28. (A) Surface damage most apparent when the damage is near an intersection of two built-up areas (stringer and frame). B) Examples of damage contained by stitching. C) Damage growing along the first stitch line/skin-stringer interface

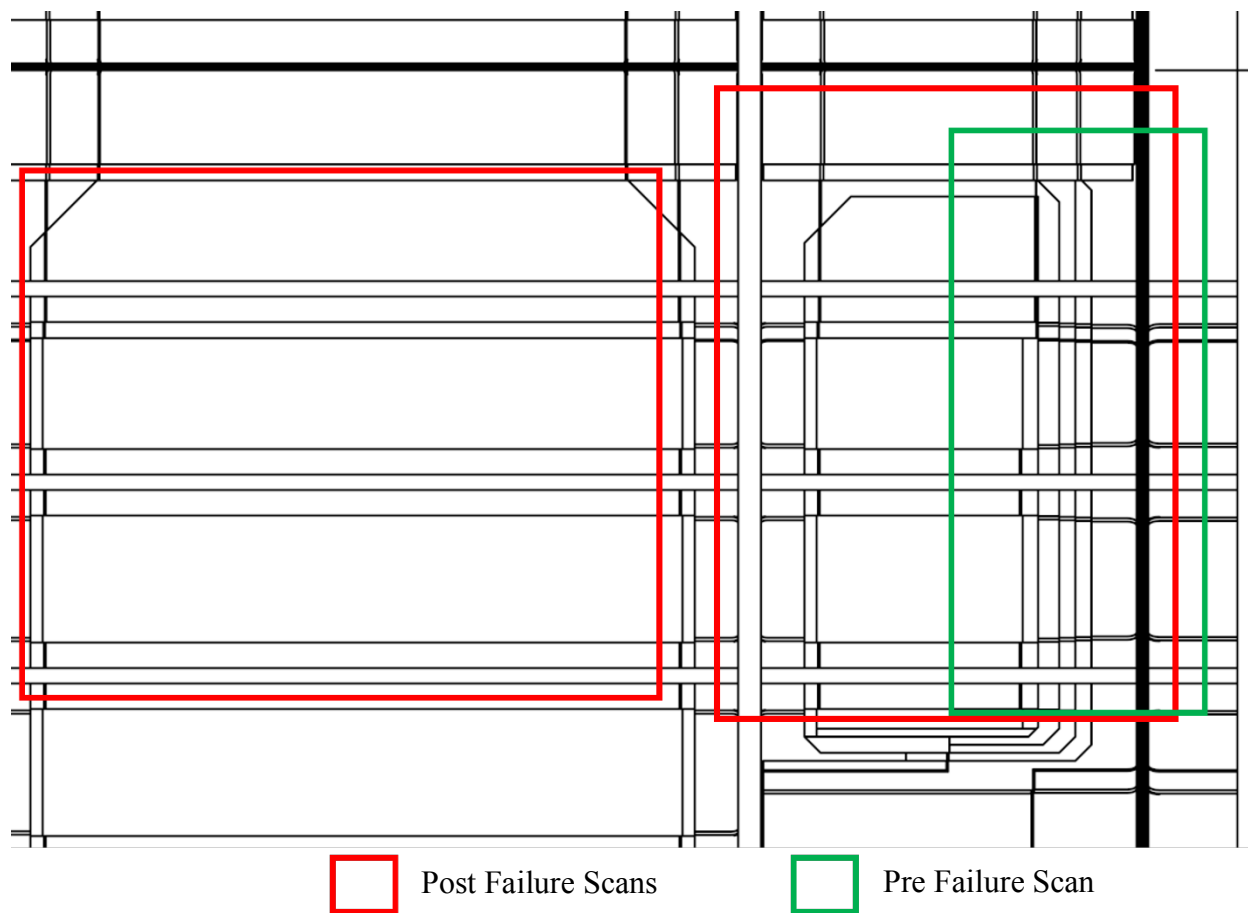
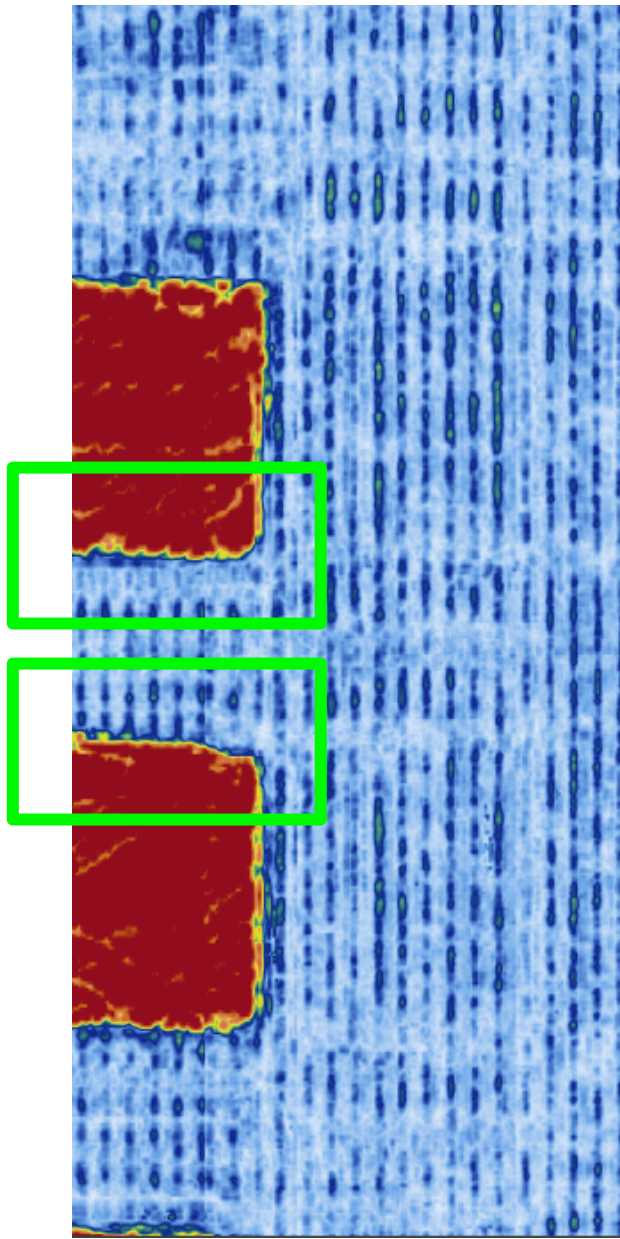
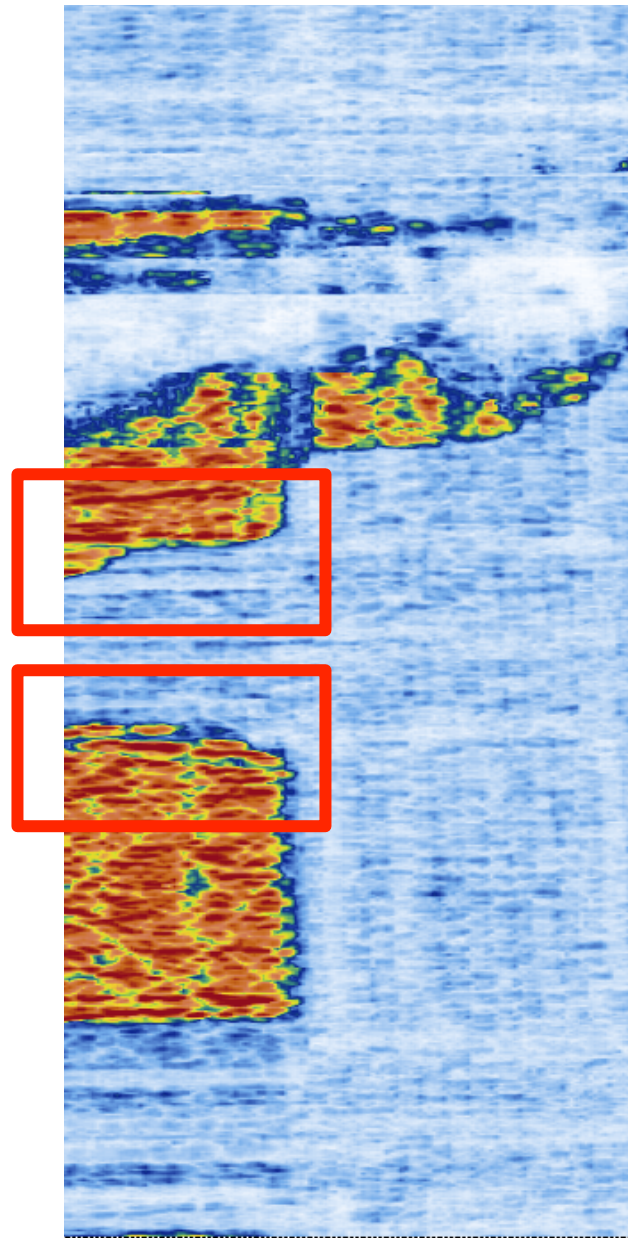
Figure 29. Overlapping sections of the pre and post failure scans on the forward portside crown section.

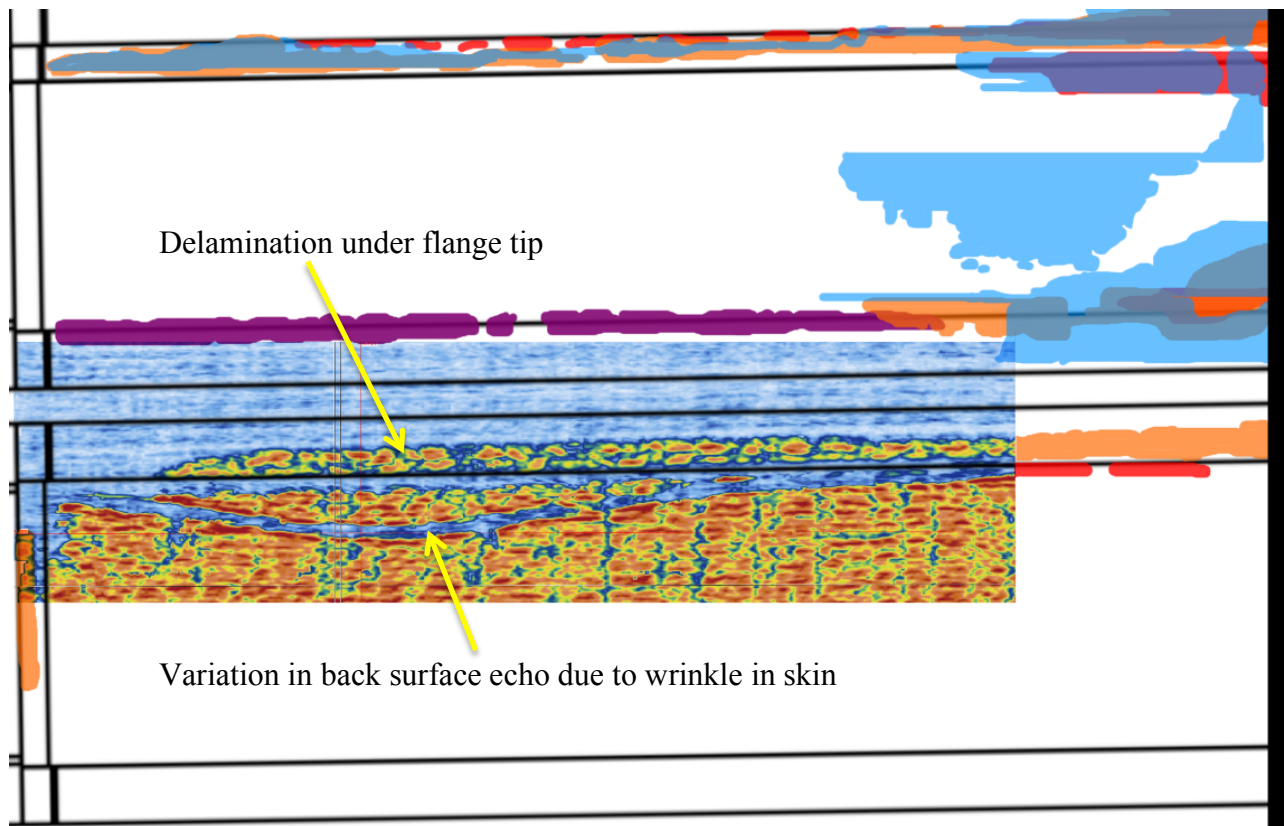
FIGURE 31. Scaled ultrasonic image overlaid with the corresponding technical drawing to show the presence of a skin layer wrinkle, which is also close in proximity to a first stitch line stringer/skin layer interface delamination.

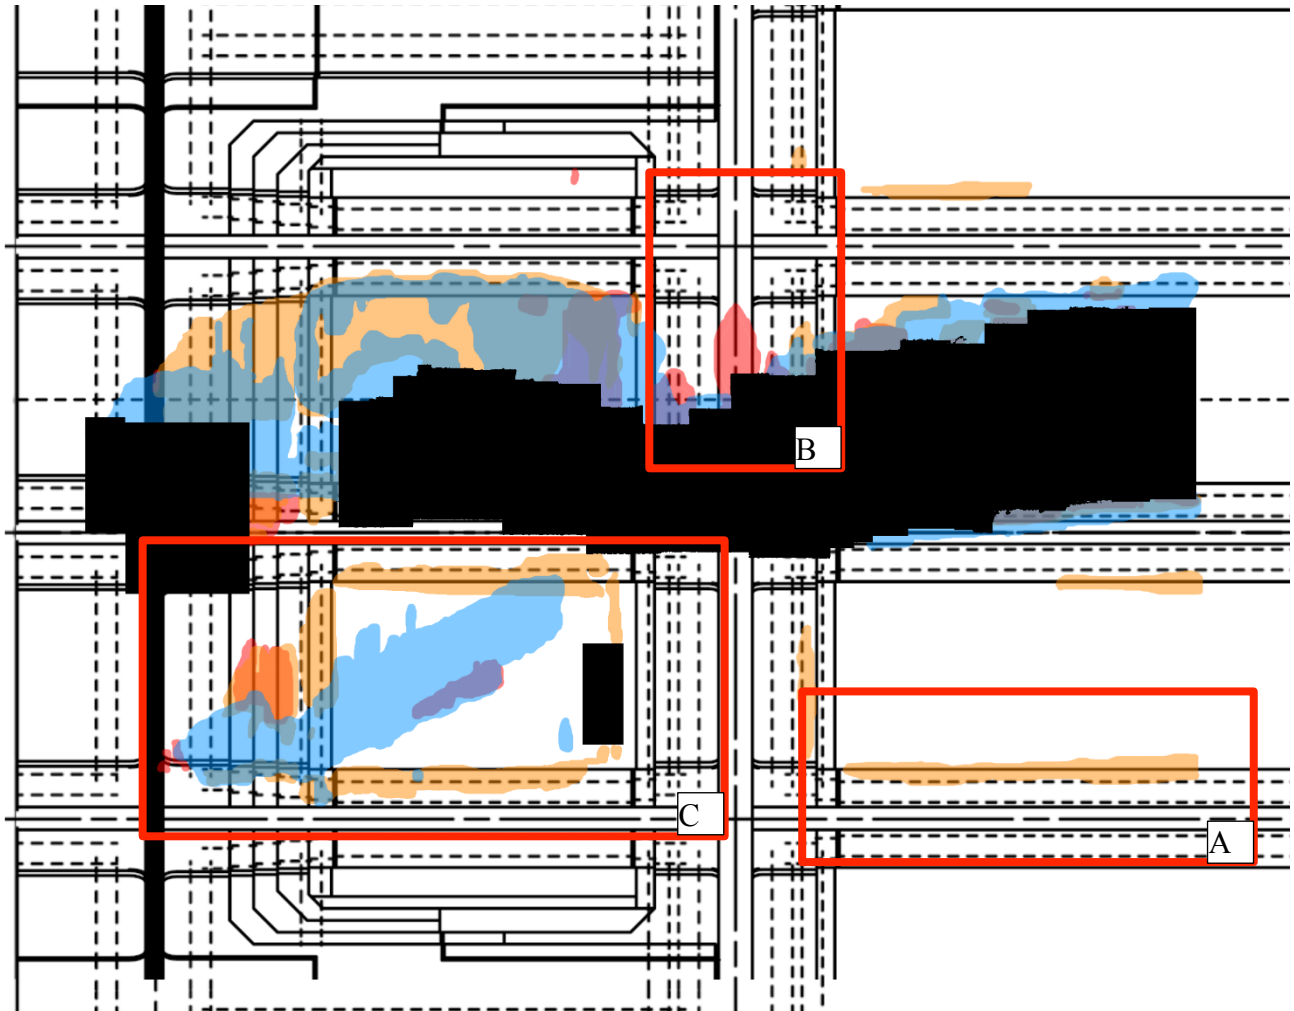
FIGURE 33. A) Delaminations between the stringer tear strap and skin interface along the first stitch line. B) Deep delaminations along the underside of the frame itself. C) Delaminations that extend beyond the stringer and into another skin bay.

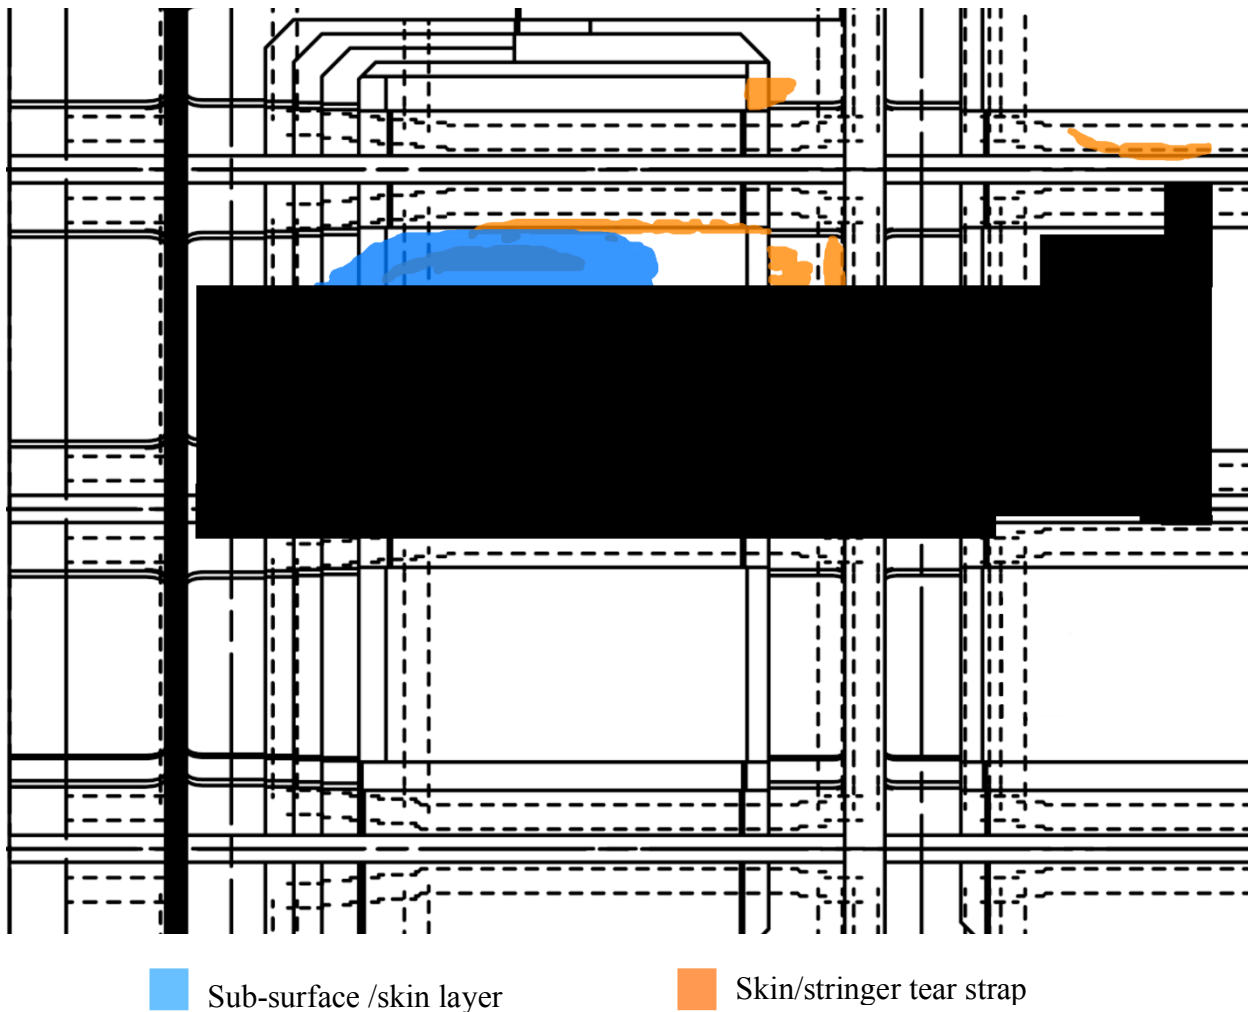
FIGURE 35. Damage map showing the delaminations surrounding the aft end of the starboard failure crack on the crown.

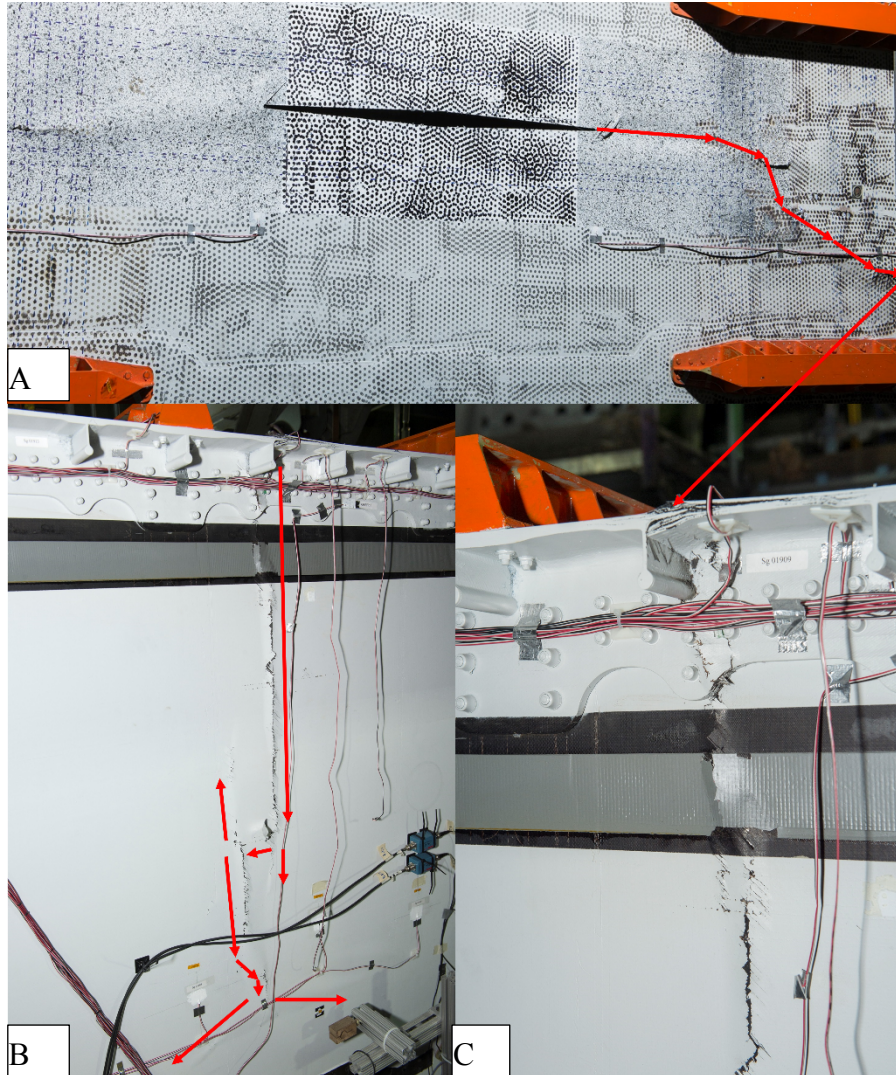
FIGURE 36. Photos of the failure crack that started from the forward side of the crown and extends into the forward bulkhead.

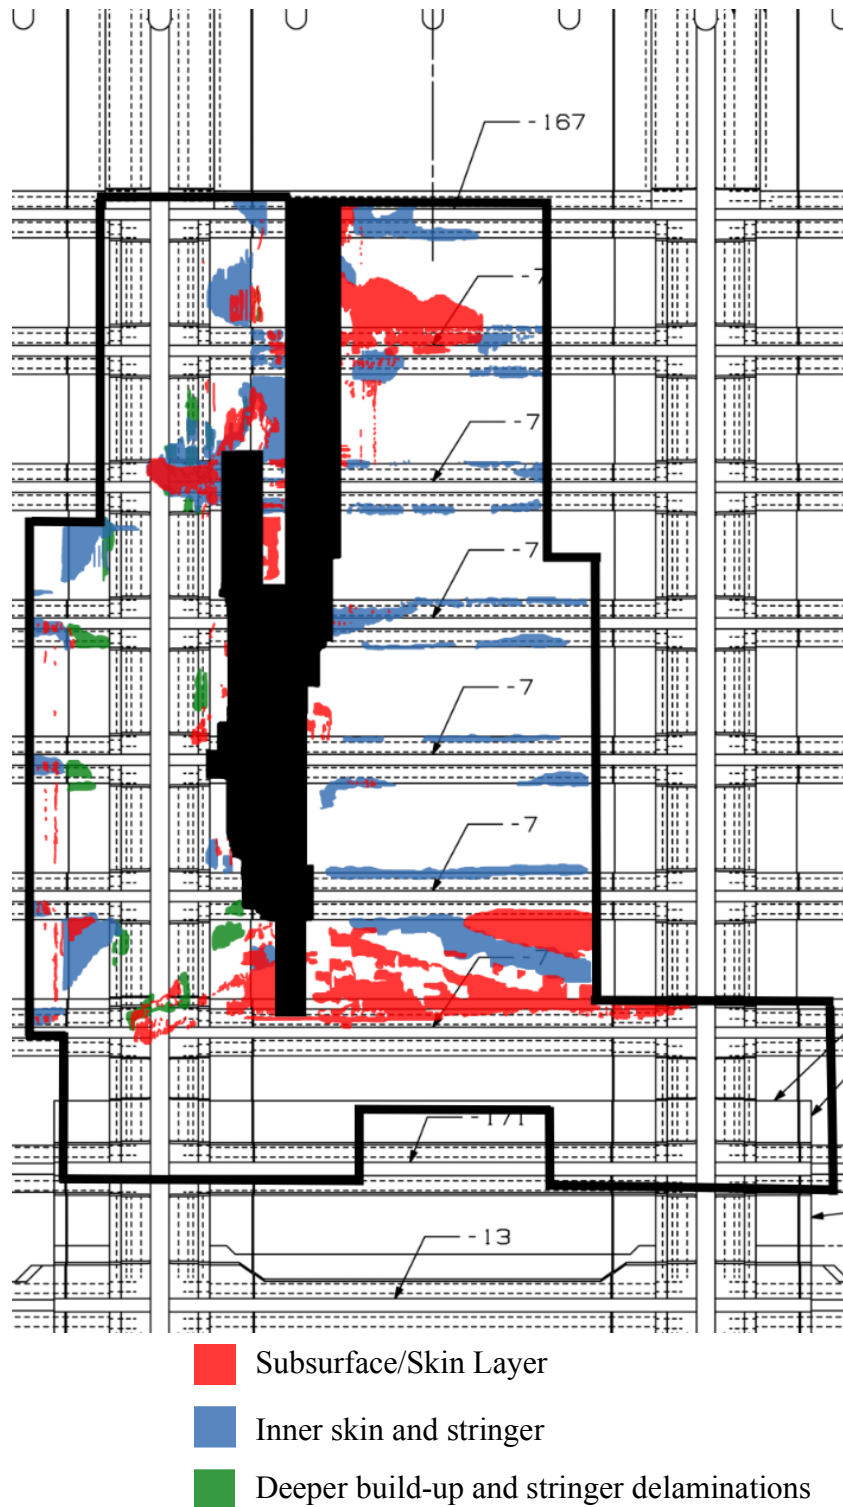
FIGURE 38. A compilation of the delamination damage from the six scans surrounding the failure crack, with the delaminations separated into three different depth locations. Areas containing cracks were too badly damaged to permit ultrasonic coupling, and are indicated in solid black.
